Organic Finishing Technologies

B-52 Paint Life Cycle Extension

Steve Finley, CTC
Support Contractor to
Mr. Tom Naguy
Air Force Research Laboratory

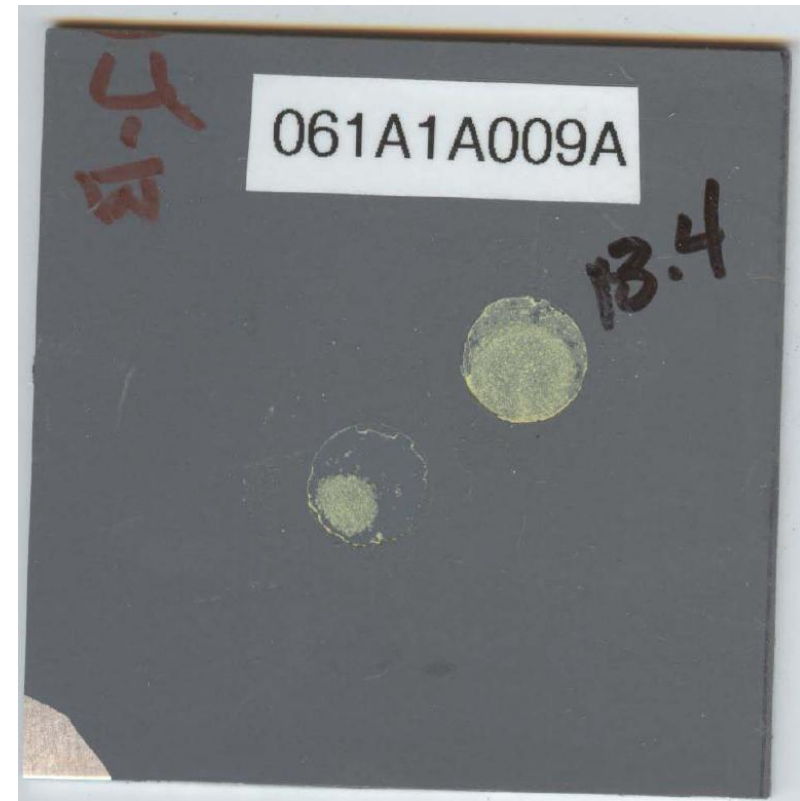
- Adhesion Testing using Pneumatic Adhesion Tensile Testing Instrument (PATTI) results
 - Six panels with two pulls per panel
 - Predominant failure mode was cohesive failure at the primer
 - Three panels showed adequate pull strength
 - Three panels were lower than desired

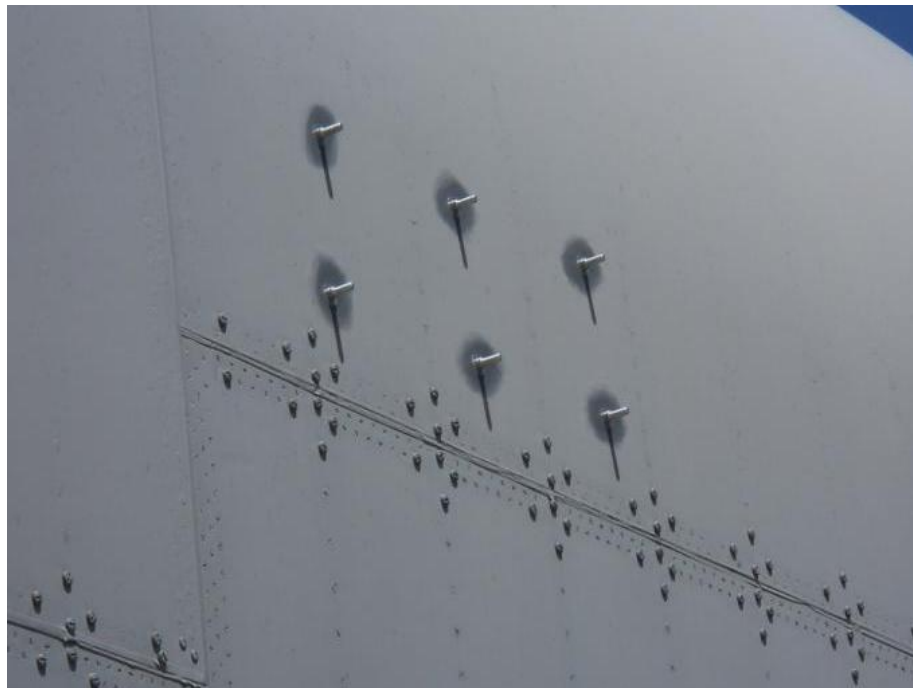
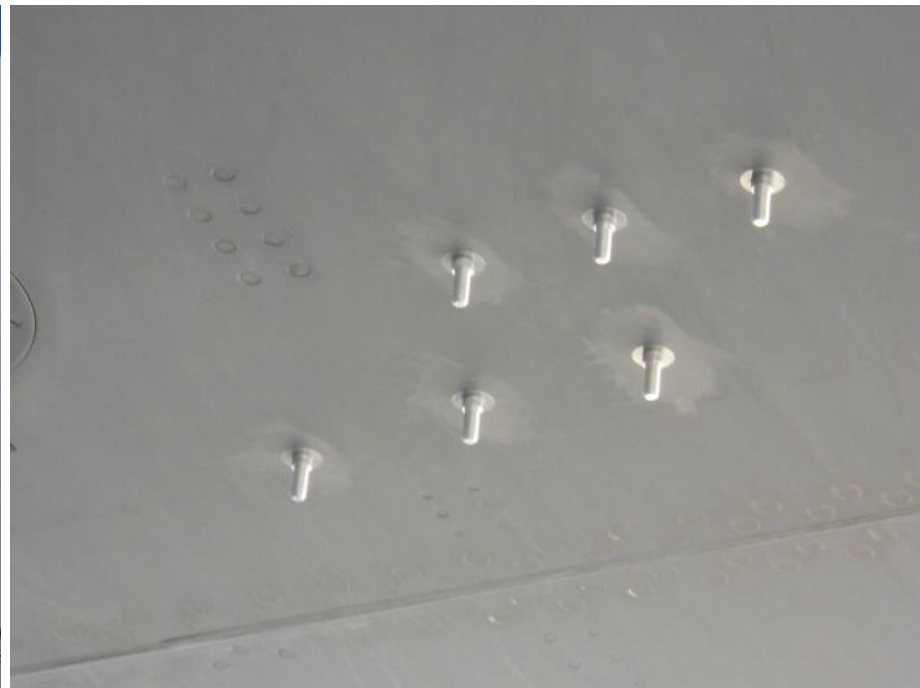
- Twelve studs glued to each aircraft
- Six under the right wing
- Six on the aft fuselage right side

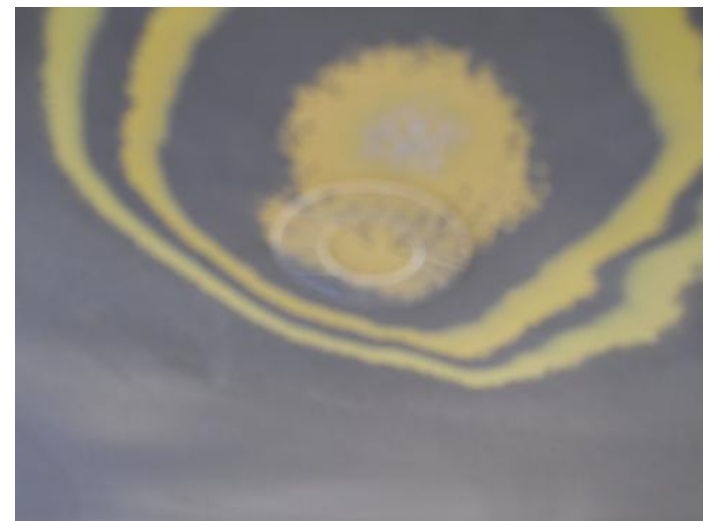
- **X-Ray Photoelectron Spectroscopy (XPS)**
 - Primer samples collected for XPS analysis
 - Coating was sanded to the base primer layer
 - Dust was collected on tape
 - PATTI studs were used for analysis
 - Fourteen samples were analyzed
- **Cr +6 level equal to or greater than fresh applied primer in 13 of 14 samples**
