Ground and Flight Testing of Non-Chrome Paint Systems; Part 2– Evaluation of Paint Systems

Air Force Corrosion Managers Conference

16-18 August 2011

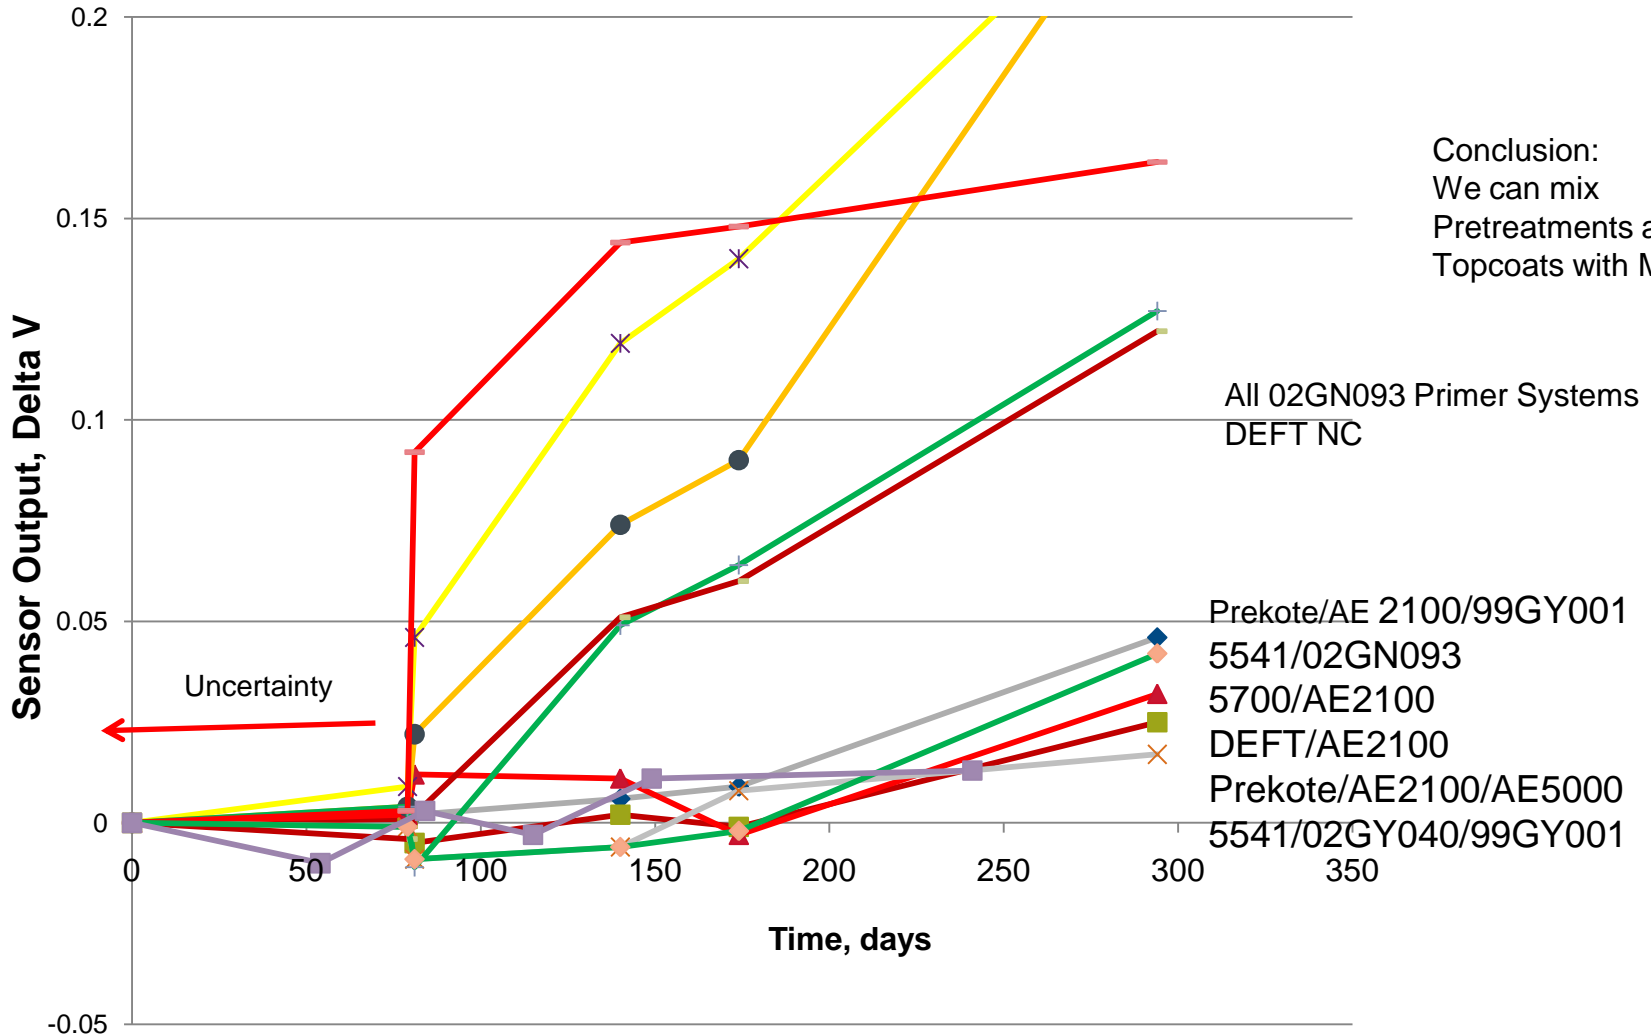
Effects of Pretreatments and Topcoats on Performance of MgRP and Comparisons To 02GN093 Primer; Daytona Ground Data

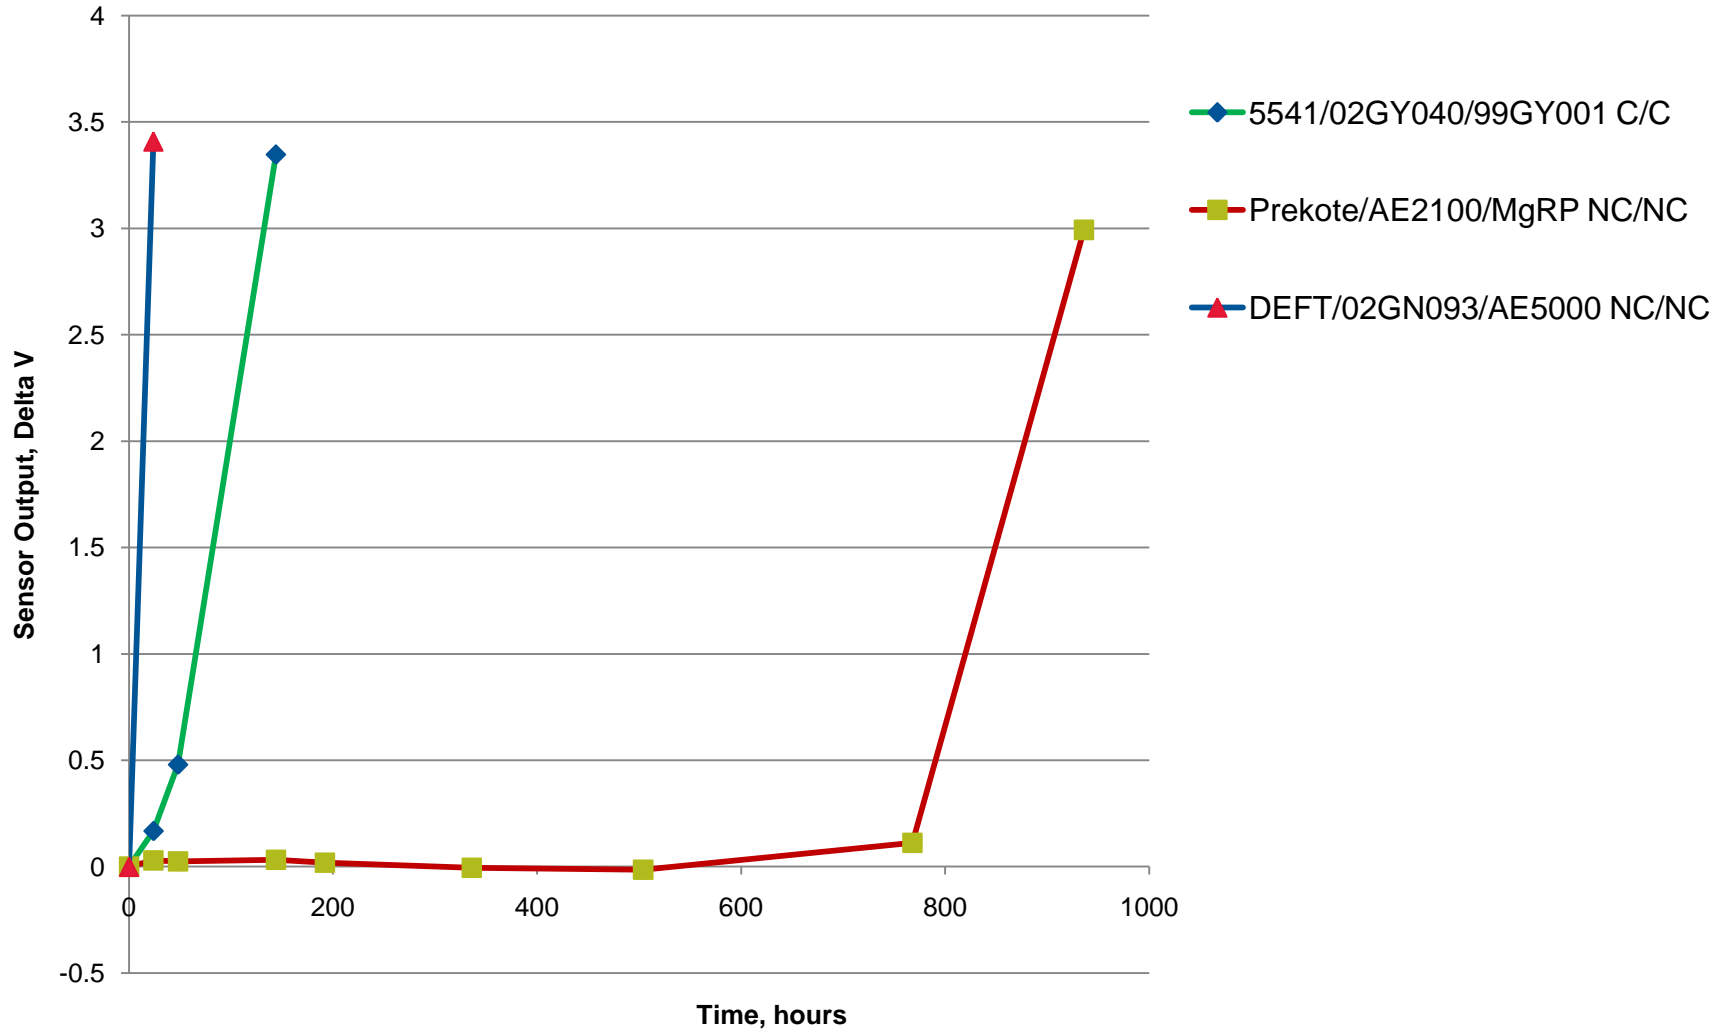
Effects of Urine on Corrosion Sensor Response For 3 Painted and Scribed Coatings; 30 C; 85% rh

- The Threats From Other Chemical Stresses Are Real and Must Be Considered In Paint Evaluations
- One NC/NC System Has Shown Exceptional Resistance
- The Following Slides Show 3 Stress Examples
 - Urine – Bilges; Cockpits
 - Decon Solutions – General Use
 - Fungal Influenced Corrosion – IML; OML (TBD)

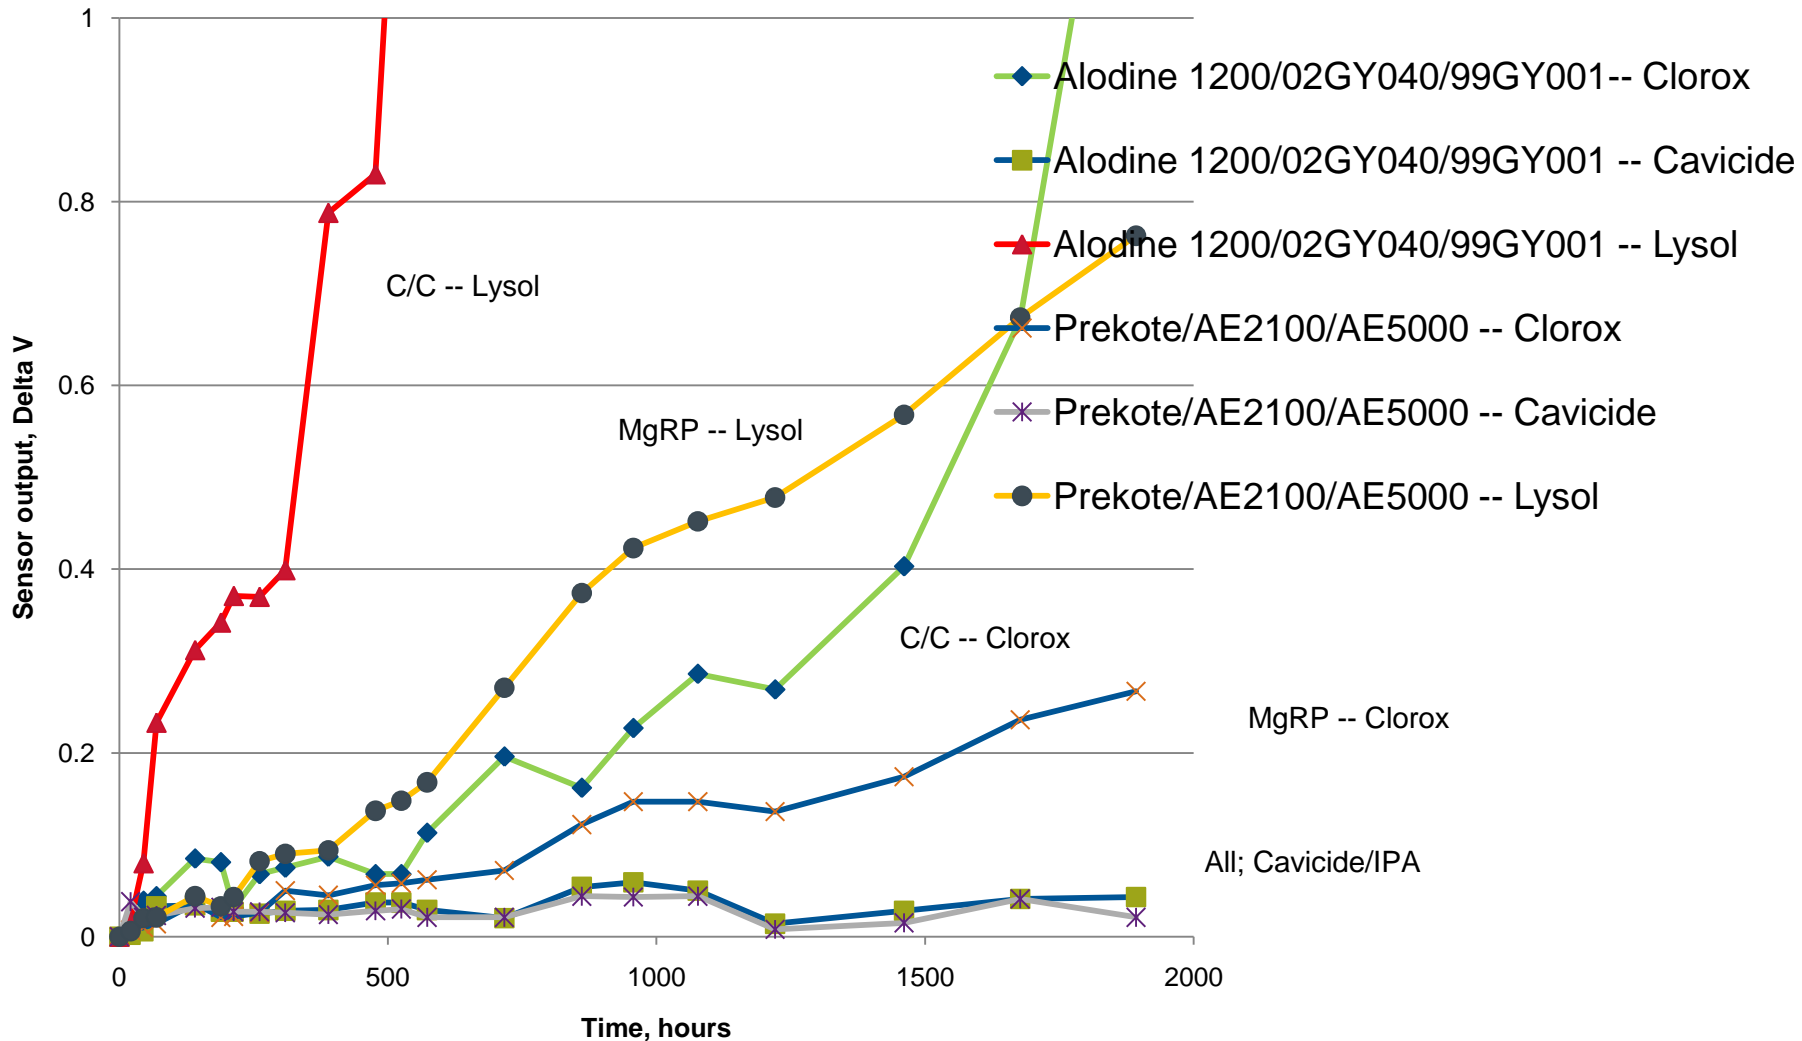
Effects of Disinfectants on Painted and Scribed Corrosion Sensors; 30 C, 85% rh; No Rinse Series

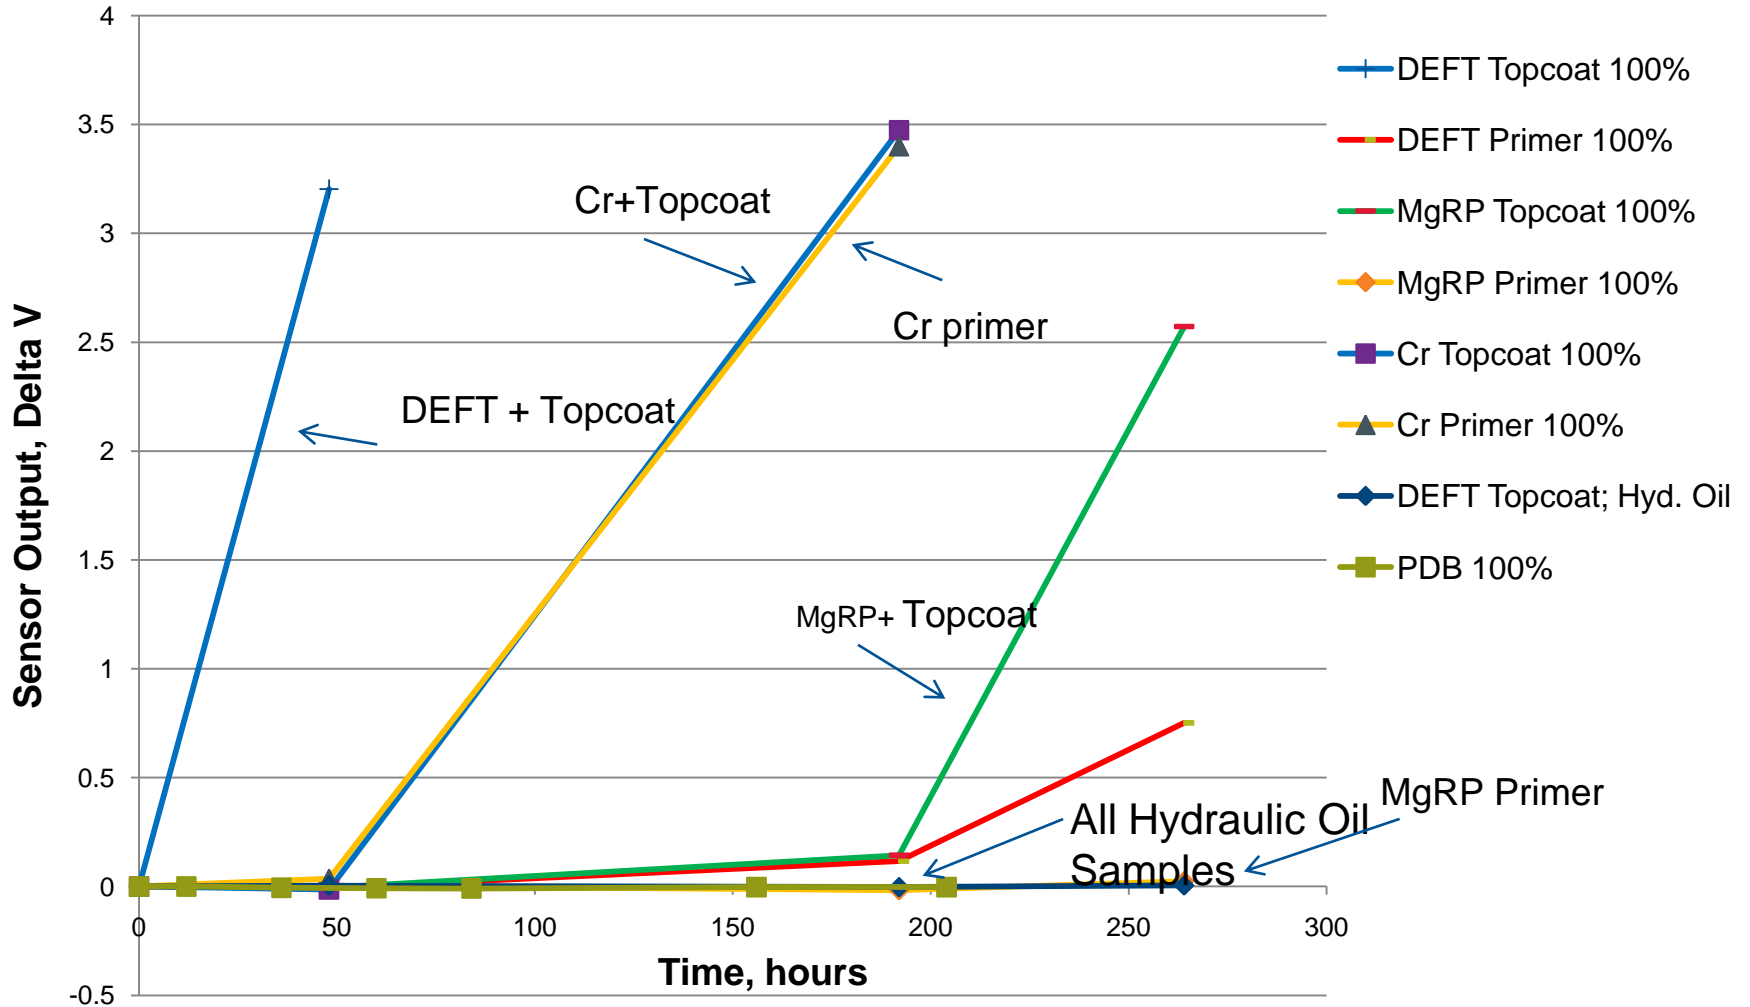
Painted and Scribed Sensors With 3 Primers (w and w/o Topcoats) Treated With Fungal Consortia In PDB Nutrient; Aged 30 C, 100 % rh

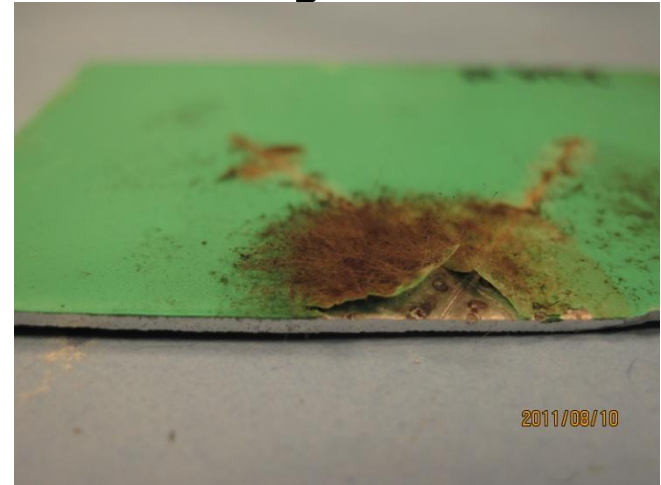
After Cutting at Middle

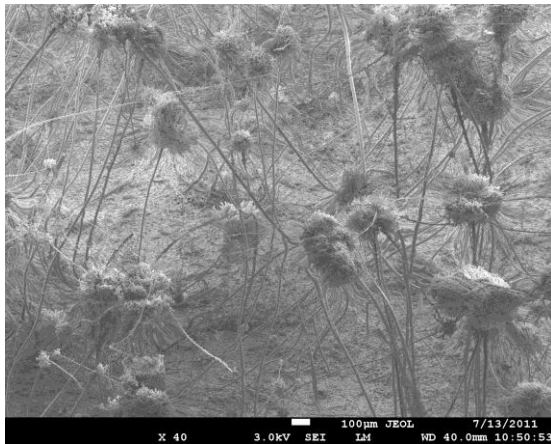
SEM View of Aerial Hyphae/Growth
