Organic Finishing Technologies

B-52 Paint Life Cycle Extension

Steve Finley, CTC
Support Contractor to
Mr. Tom Naguy
Air Force Research Laboratory

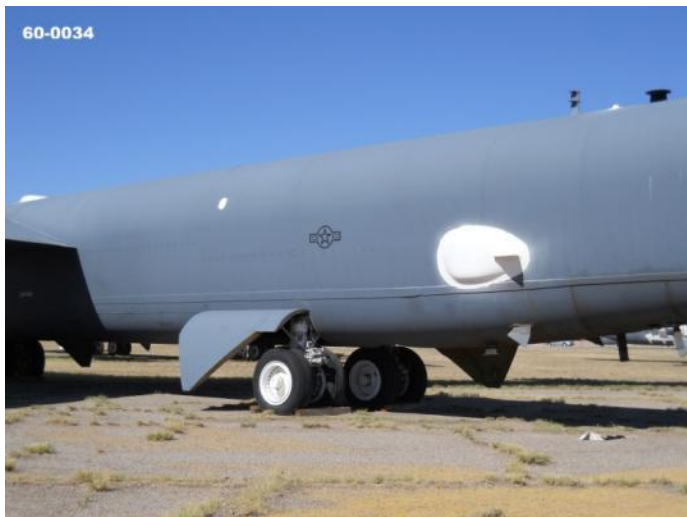
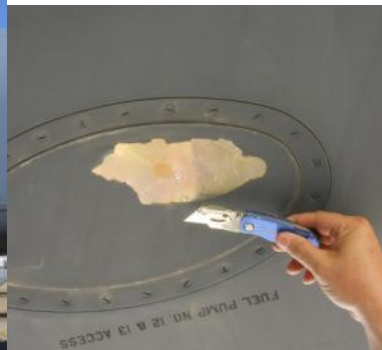
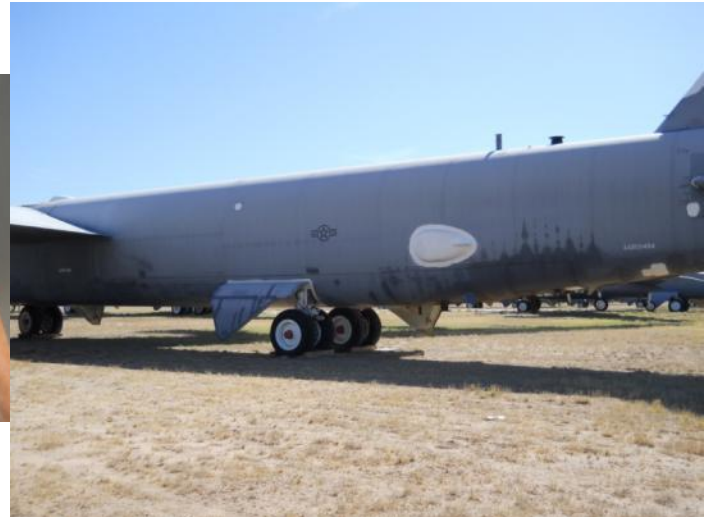
- One adhesion failure noted on the inboard fuel access panel on the bottom of the right wing aircraft 60-0014
- Aircraft from Barksdale showed higher degree of coating degradation
- Minot aircraft showed little signs of degradation
- No corrosion noted on any of the aircraft observed

- Several adhesion failures noted on multiple aircraft; some as large as 20 ft²
- No corrosion was detected during the visual inspection
- No facility to accomplish maintenance touch up
- Color, gloss, and film thickness readings taken on three APC aircraft
